Chicago Committee on High Rise Buildings

## Seminar on Recladding of the Amoco Building in Chicago, Illinois

November 1995  
Report No. 15

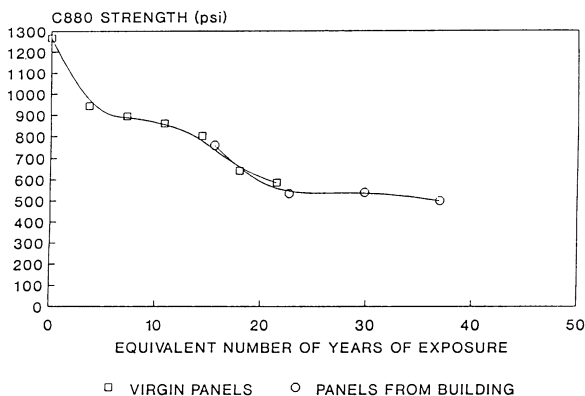
Fig. 3-8 -

Examination of the ASTM C880 flexural strength tests performed on the virgin original marble panels stored inside the building before and after exposure to the accelerated weathering test conditions revealed that 100 cycles of the laboratory simulated weathering are approximately equivalent to about 10 years weathering in Chicago, as shown in Fig. 3-8.

C880 strength - 15 years of exposure. One hundred cycles of laboratory simulated weathering are approximately equivalent to about 10 years.

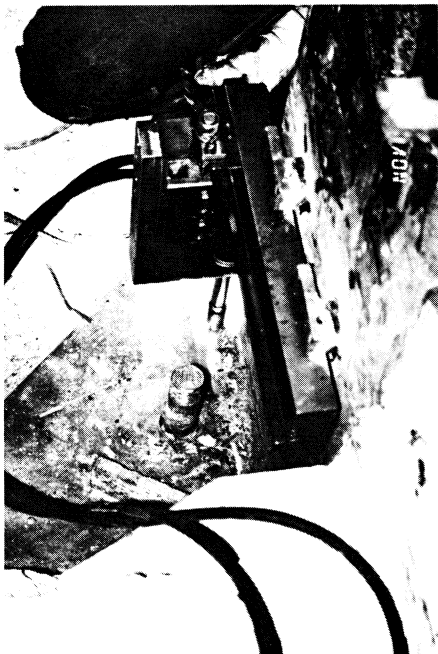
Fig. 10-1 -

Portable end mill used to machine smooth, flat surface to base plate of column.

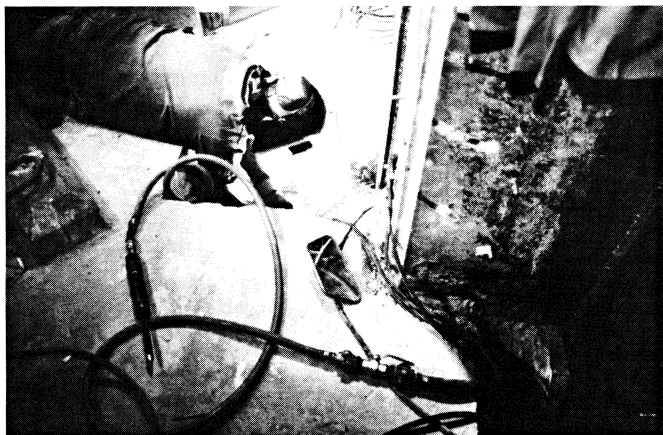
Fig. 10-2 -

The existing steel plate columns were up to 2-1/2 inches thick, therefore the American Welding Society (AWS) D1.1 welding code requires that the steel plate be preheated. Preheating was done to 225 degrees F and was limited to the area being welded to avoid expanding too great a length of the column. Because this was an occupied building, smoke that occurred from the welding operation was controlled with a "smoke-eater". The smoke-eater sucks in smoke from the area of the welding, pumps it to a filter, and filters the smoke.

Welding of steel reinforcing plates to existing column.

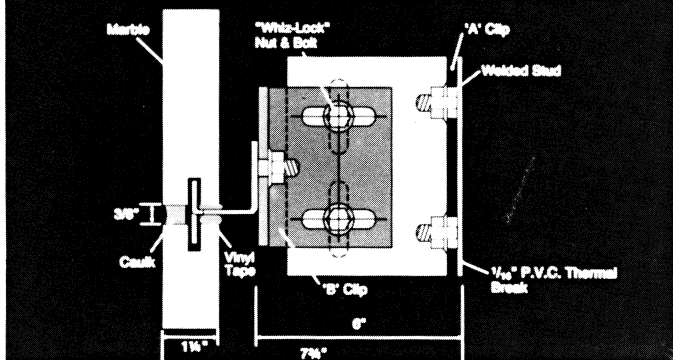
Fig. 11-1 - Section through original marble panels showing existing conditions.

The focus of examining the existing conditions was to find a design solution for the new cladding of which three elements were of major concern: the granite panel which includes the thickness in the kerf design, the shelf-angle design, and the supporting A and B Clips which were the elements of adjustment. We chose to keep A and B clips because there were over 176,000 of these angles on the building and therefore a very costly element to replace.

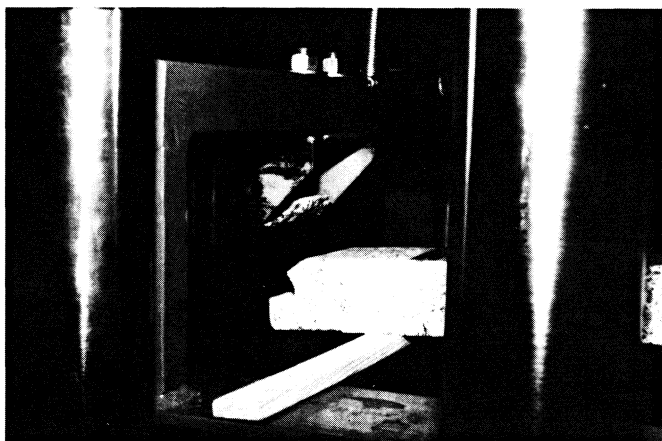
Fig. 12-3 - Fractured end of kerf sample after testing.

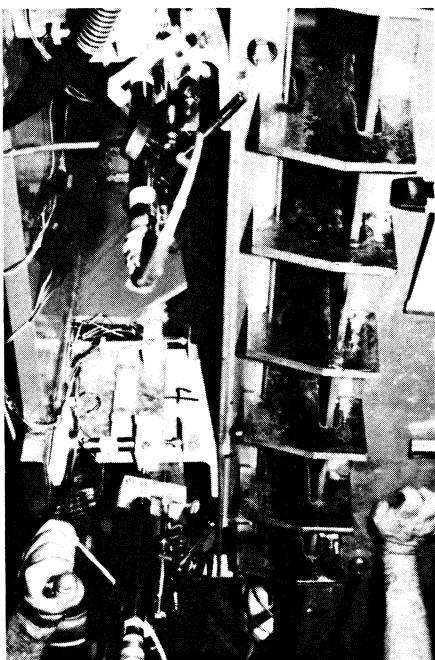
**Fig. 12-13 - Bending of shelf angle at load of ten times design load.**

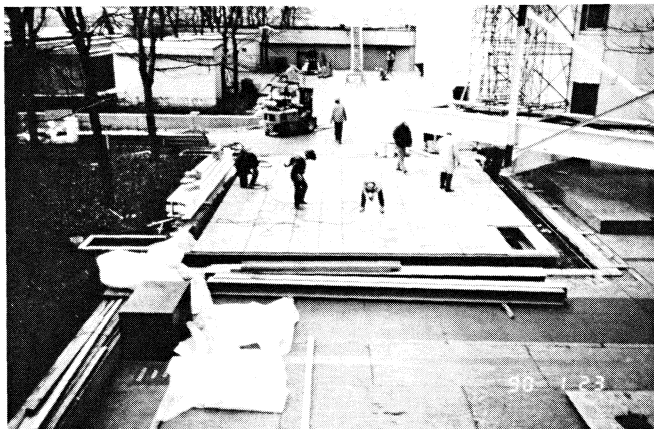
After a review of the construction loads that would be required on the plaza level, it was determined by WJE that it would be necessary to reinforce the plaza. The reinforcement was accomplished by a combination of installing new shear reinforcement in the beams, and by installing a grillage of steel beams and steel plates over the surface of the plaza area, as shown in Fig. 15-4.

**Fig. 15-4 - Grillage constructed over plaza areas to support construction loads.**

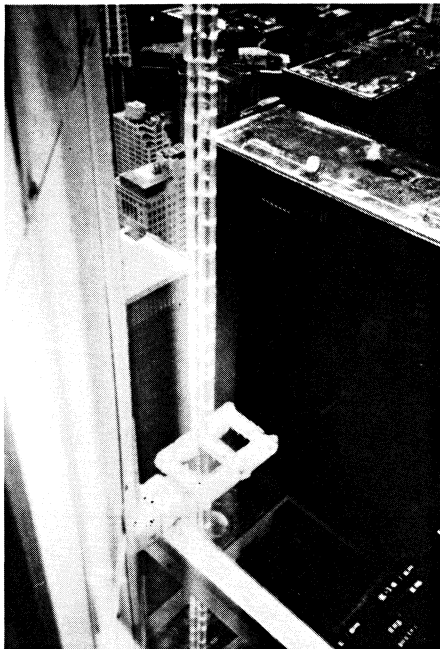
**Fig. 16-3**

The stages were suspended from an outrigger beam system attached to the building window-washing track. Scaffold suspension cable guides shown in Fig. 16-3 were incorporated on the outside of the monorail brackets and custom-designed spring-loaded tie-down brackets were mounted at the base of the building to keep tension on the cables.

**View of scaffold cable guide. Ice formed on the cables and on the guide on some winter days.**

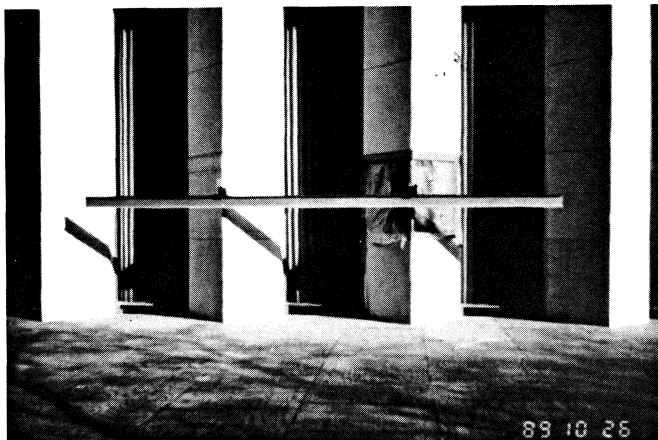
The monorail and cable guide assemblies were attached to the building with steel brackets fabricated to conform to the chevron shape of the structural steel behind the stone. When the existing marble was removed at each bracket location, the structural steel was then drilled and tapped for bracket connection bolts. The brackets were installed and then plywood custom painted to match existing marble, as shown in Fig. 16-5 was then installed and sealed to weather-protect the cavity.

Fig. 16-5 - View of cover over monorail bracket.

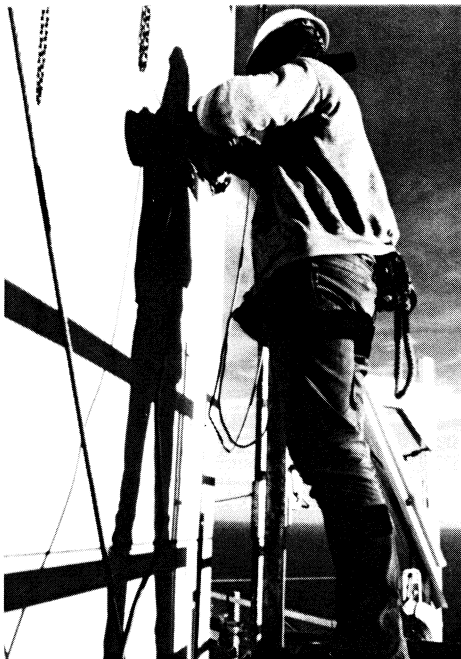
Work started at the third floor. Eight courses of marble were removed. The first course starting at the top was removed by saw-cutting through the stone using a diamond blade just below the top stone anchor, as shown in Fig. 16-7. Then by using a small prybar, we leaned the stone out just enough to attach a stone clamp onto the piece, as shown in Fig. 16-8. The stone clamps were then placed on all individual stones in the remaining seven courses before disconnecting their tie-in anchors as we worked our way down.

**Fig. 16-7 - View of sawcutting of panels prior to removal.**

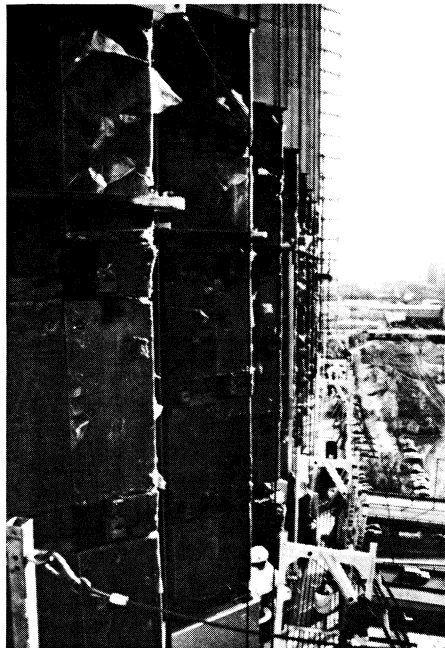
**Fig. 16-9 -**

After the first course of marble was removed at the start of each jump, a stone alignment template, as shown in Fig. 16-9 (each chevron had one) which forms the shape of the chevron was attached to the window-washing track. Being unable to use control lines for installing the new granite, we had to devise a new method for its installation. Since the window-washing track was located at the jambs of every window and the existing marble fit between the tracks, it made sense to use the tracks as a guide. The template was fabricated to fit in the track as well as accommodate the additional 3/4 inch outward plane of the new granite. Segmented straight edges were then hung on the templates and tethered to the static line mounted above the templates for safety.

**View of horizontal  
stone alignment  
template and vertical  
straight edge.**

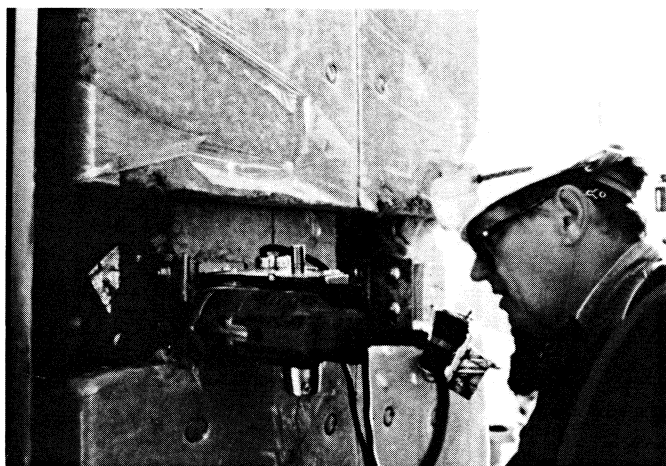
**Fig. 16-10 -**

The existing A clip previously mentioned was then drilled through using a mag drill with a special 2-step drill bit attached to the B clip, as shown in Fig. 16-10. This enabled us to drill and tap the structure to receive a 3/8-in. bolt in the center of the two, 1/2-in. studs without removing the A clip. The mag drill was equipped with a quick-change chuck for speed and to ensure proper alignment for drilling and tapping. After all courses of marble had been removed and all A clips had received the new 3/8-in. bolts, we then started our granite installation.

**View of drilling of A-clip with a mag drill.**

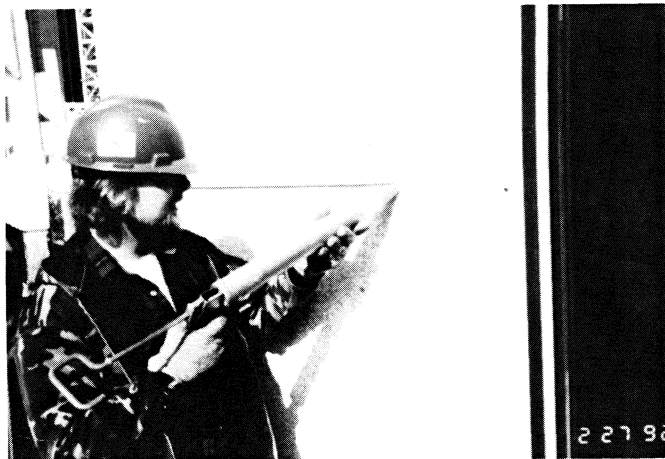
We caulked the building, as shown in Fig. 16-14 using the same scaffolds and basically the same procedures, only in reverse.

Fig. 16-14 - View of sealant installation.

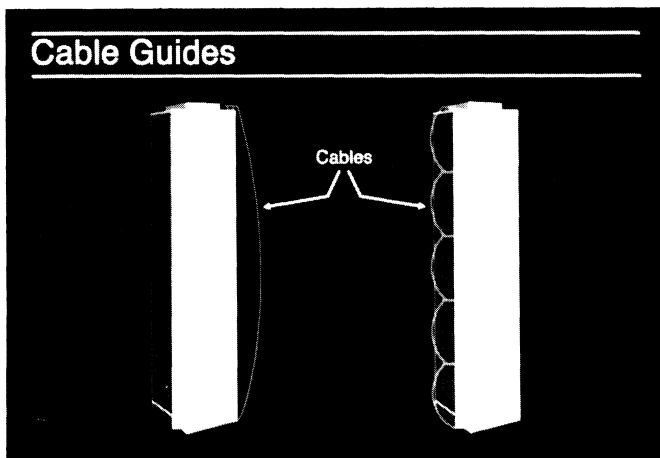
gauges placed on the hoist towers at the half-way points and also took readings on the roof and at grade. We shut an individual hoist down based on the readings in each corner. As you can see, the other wind issue that we contended with was the wind whipping the cables. The reason for the cable guide, I think, is self-evident in Fig. 17-2. These guides can take credit for eliminating damage to stone, both marble and granite. We had plenty of high winds, over a hundred cables that spanned the height of the building right next to the building, but never damaged any stone.

Fig. 17-2 - Extent of cable guides used to restrain cables.
